REPORT DOCUMENTATION PAGE		READ INSTRUCTIONS BEFORE COMPLETING FORM
1. REPORT NUMBER	2. GOVT ACCESSION NO.	3. RECIPIENT'S CATALOG NUMBER
	AD-A108	172
4. TITLE (and Subtitle) National Program of Inspection of Non-Federal Dams Tennessee. Marys Creek Dam No. 8 (Inventory Number TN 15727) near Cross Roads, Tennessee, Shelby County, TN, Wolf River Basin		5. TYPE OF REPORT & PERIOD COVERED Phase 1 Investigation Report

MARY'S CREEK WATERSHED DAM NO. 8
SHELBY COUNTY
MARCH 27, 1981

PHASE I INSPECTION REPORT
NATIONAL DAM SAFETY PROGRAM
TENNESSEE

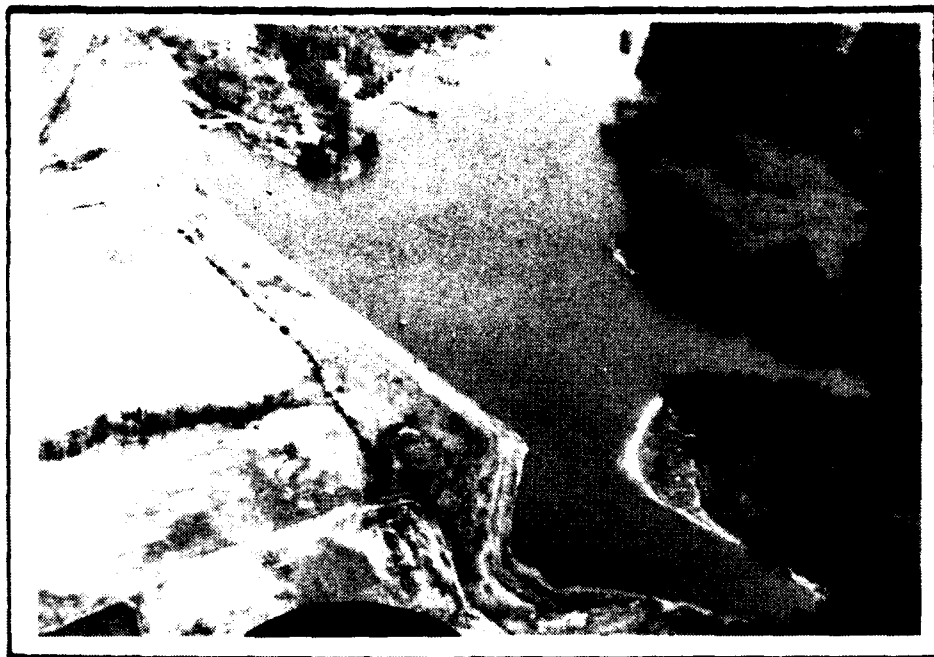
PHOTO NO. 1

Approximately 106 feet to the right of the dam is a small open channel following the natural contour of the abutment. It has a width of 20 feet at the top of the dam with 1.1 feet of available head. The channel was apparently excavated as part of a terracing system (see photo no. 1). The hydraulic capacity of the channel was considered in the flood routing.

- Photo No. 1 - Aerial shot.
- Photo No. 2 - Aerial shot showing Stotts Lake Dam upstream of Mary's Creek.
- Photo No. 3 - Aerial shot looking downstream.

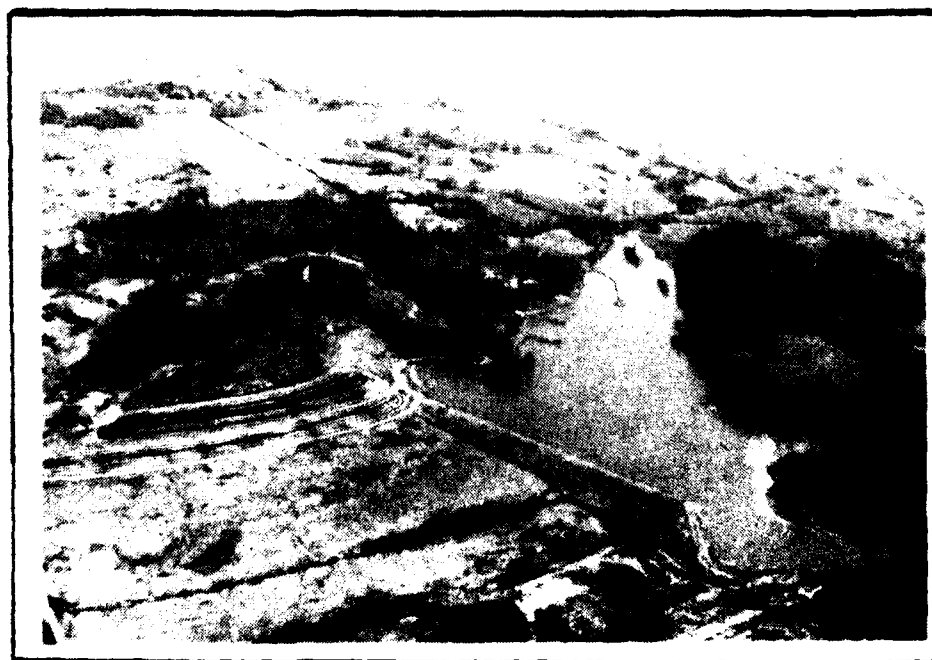
PHOTO NO.4

- Photo No. 4 - Aerial shot looking upstream.
- Photo No. 5 - Downstream slope of dam from left.
- Photo No. 6 - Downstream slope and curvilinear portion of dam.

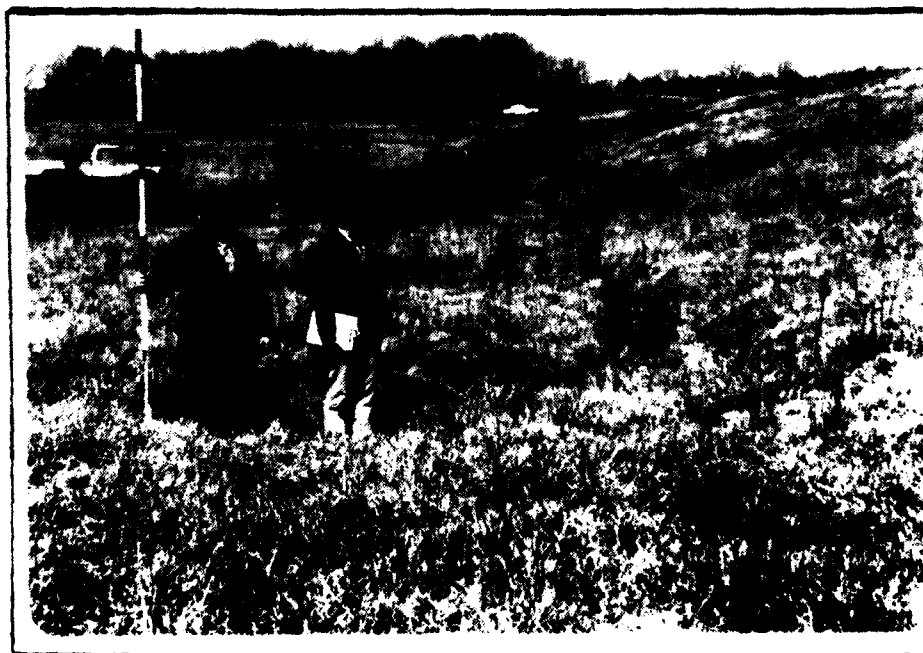
PHOTO NO. 8

- Photo No. 7 - Riser.
- Photo No. 8 - Downstream of toe showing excavated drainage ditch.
- Photo No. 9 - Sloughing along upstream slope just right of emergency spillway.

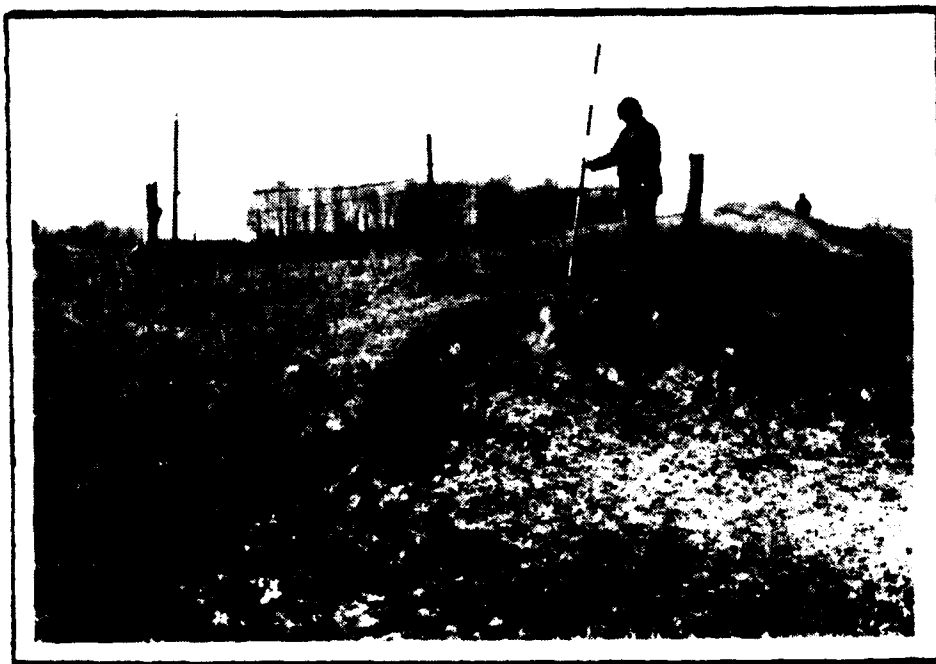
PHOTO NO. 10

- Photo No. 10 - Sloughing along entrance channel of emergency spillway.
- Photo No. 11 - Stilling basin from crest.
- Photo No. 12 - Downstream channel.

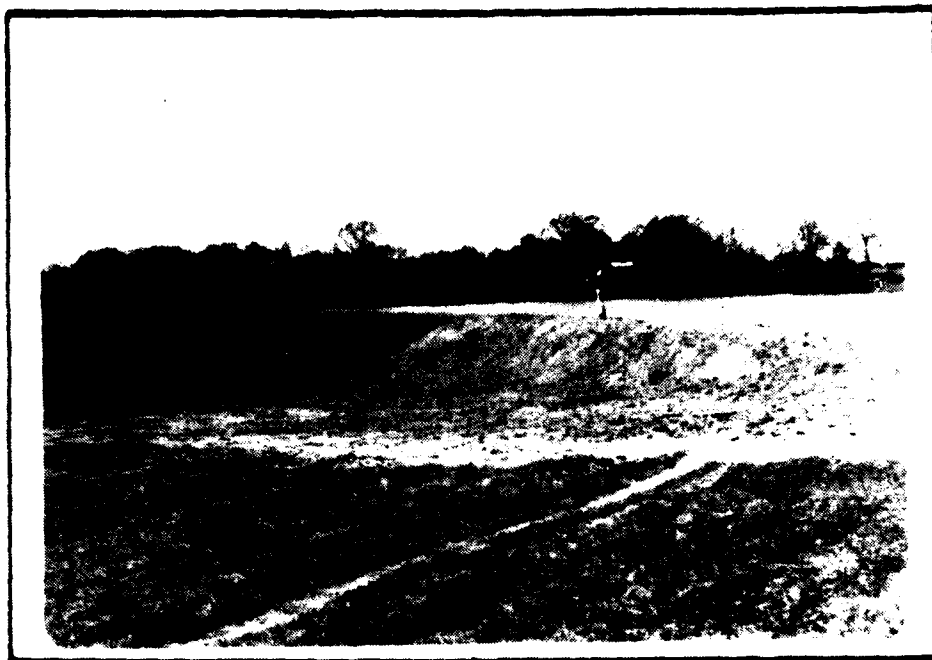
PHOTO NO.1

- Photo No. 1 - Downstream slope at left end of dam showing new fill material.
- Photo No. 2 - Downstream slope looking left from mid-section.
- Photo No. 3 - Downstream slope from emergency spillway exit channel.
- Photo No. 4 - Crest of dam looking right from near mid-section.
- Photo No. 5 - Upstream slope of dam showing extensive sloughing.
- Photo No. 6 - Upstream slope at left end of dam.
- Photo No. 7 - Depression on downstream side of crest.
- Photo No. 8 - Muskrat hole on crest.
- Photo No. 9 - Sloughing along upstream slope (turned 90°).
- Photo No. 10 - Longitudinal surface crack along upstream slope of new fill material at left end of dam.
- Photo No. 11 - Spillway, from right of dam.
- Photo No. 12 - Spillway, looking upstream.
- Photo No. 13 - Eroded area along spillway channel approximately 150 feet downstream of dam.
